Checklist for Stormwater Report

TABLE 1: ORIGINAL, EXISTING & PROPOSED CONDITIONS - PEAK RUNOFF RATES & TOTAL RUNOFF VOLUMES
1089 Millbury Street - Worcester, Massachusetts

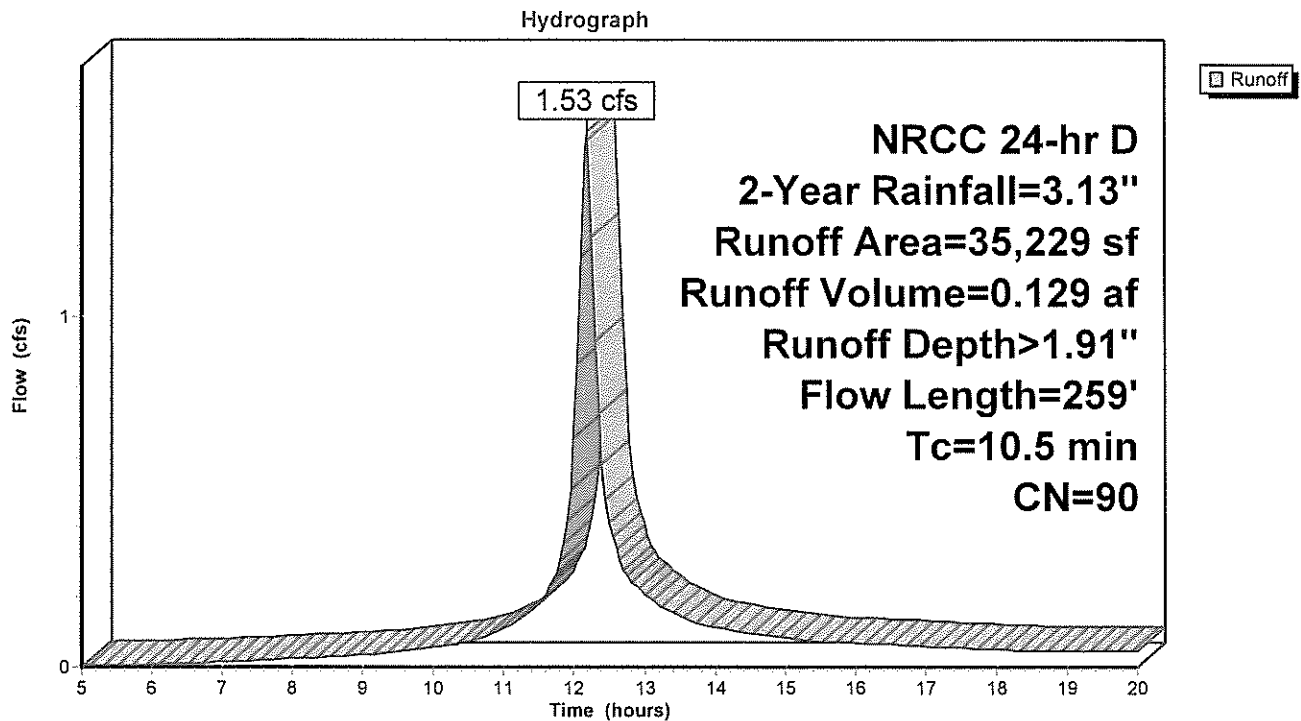
Subcatchment 1089: Current 2020 Conditions 1087-1089 Millbury St. TOTAL LOT

Tc (min)	Length (feet)	Slope (ft/ft)	Velocity (ft/sec)	Capacity (cfs)	Description
9.8	32	0.0600	0.05		Sheet Flow, Sheet Flow
					Woods: Dense underbrush n= 0.800 P2= 3.13"
0.1	73	0.4500	10.80		Shallow Concentrated Flow, Shallow Concentrated
					Unpaved Kv= 16.1 fps
0.6	154	0.0840	4.67		Shallow Concentrated Flow, Shallo Concentrated
					Unpaved Kv= 16.1 fps
10.5	259	Total

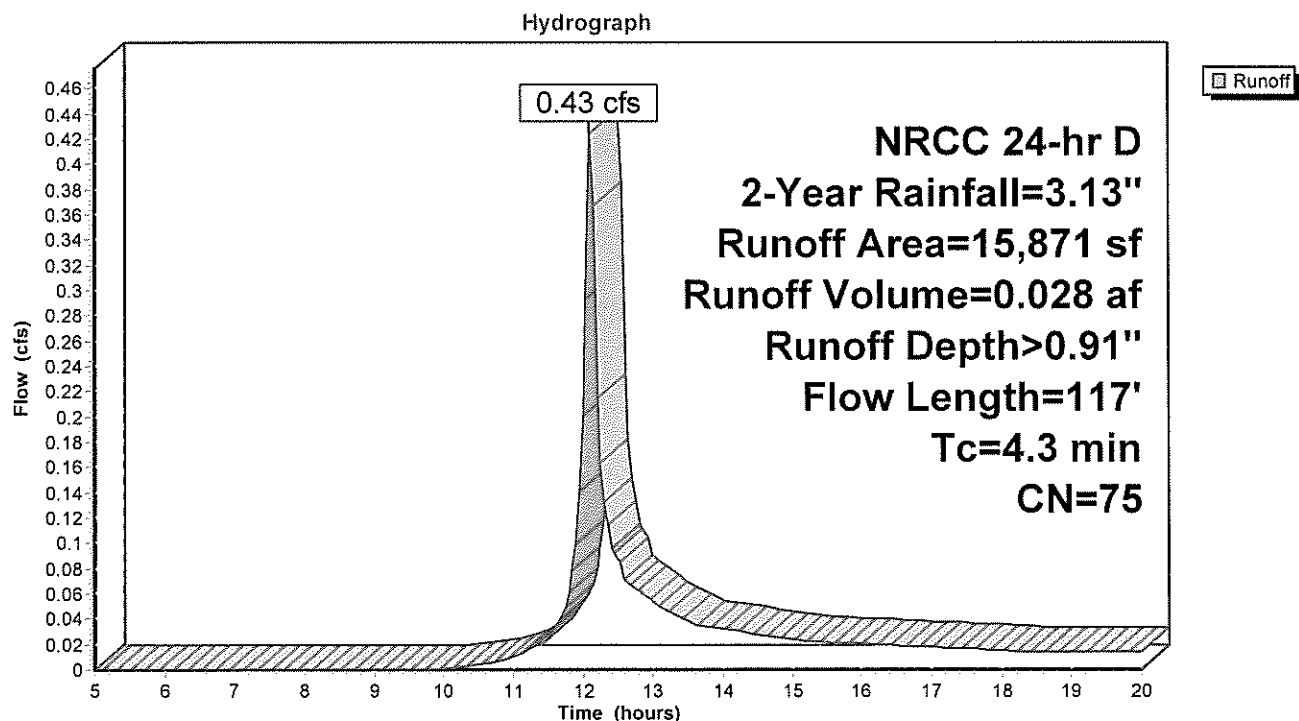
Subcatchment P-A: Poposed 2021 Conditions 1087-1089 Millbury St. Upper Section to Drain Syst

ary for Subcatchment P-A: Poposed 2021 Conditions 1087-1089 Millbury St. Upper Section to Dra

Runoff = 0.43 cfs @ 12.11 hrs, Volume= 0.028 af, Depth> 0.91"
 Routed to Pond CB1 : Catch Basin 1

Tc (min)	Length (feet)	Slope (ft/ft)	Velocity (ft/sec)	Capacity (cfs)	Description
2.4	10	0.2000	0.07		Sheet Flow, Sheet Flow-1 Trees Woods: Dense underbrush n= 0.800 P2= 3.13"
1.6	40	0.3000	0.41		Sheet Flow, Sheet Flow 2 - Grass Grass: Short n= 0.150 P2= 3.13"
0.3	67	0.3000	3.83		Shallow Concentrated Flow, Shallow Concentrated Short Grass Pasture Kv= 7.0 fps
4.3	117	Total

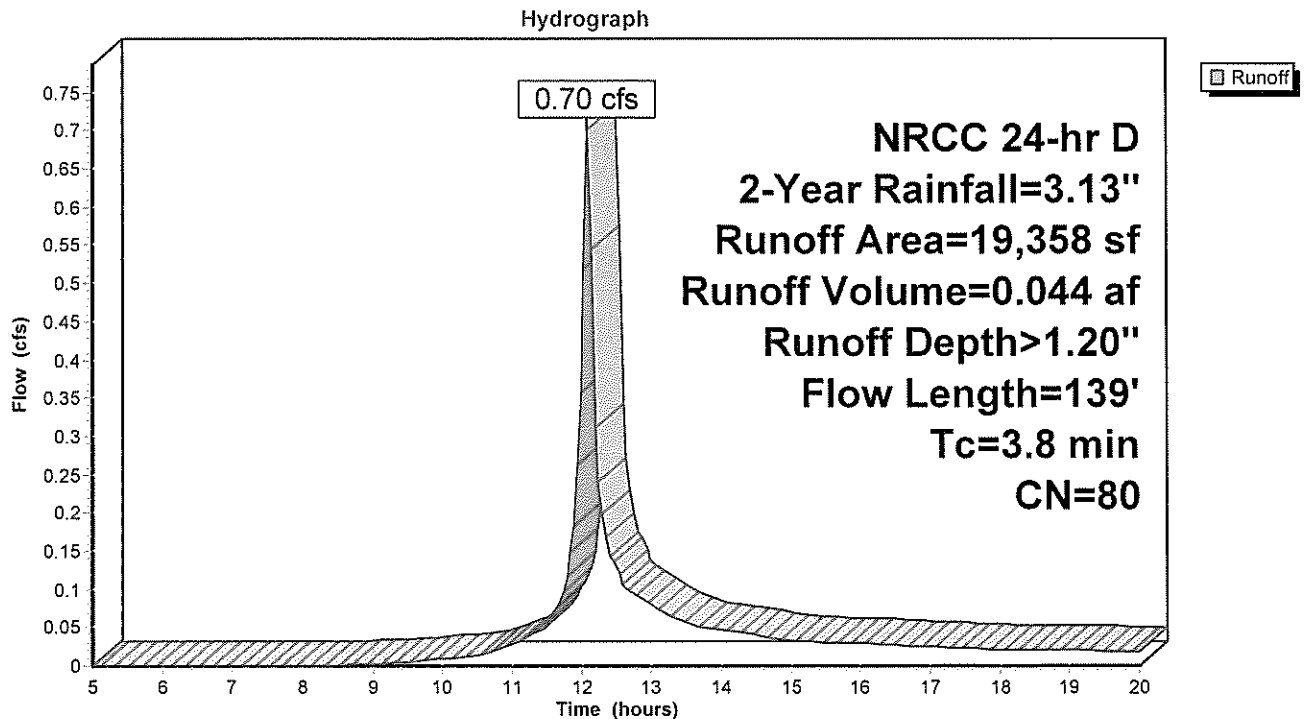
Subcatchment P-B: Poposed 2021 Conditions 1087-1089 Millbury St. Lower Section To Millbury St

ry for Subcatchment P-B: Poposed 2021 Conditions 1087-1089 Millbury St. Lower Section To Mill

Runoff = 0.70 cfs @ 12.10 hrs, Volume= 0.044 af, Depth> 1.20"
 Routed to Link MS : Design Point - Millbury Street

Tc (min)	Length (feet)	Slope (ft/ft)	Velocity (ft/sec)	Capacity (cfs)	Description
3.0	50	0.1000	0.28		Sheet Flow, Sheet Flow - Grass
					Grass: Short n= 0.150 P2= 3.13"
0.8	89	0.0700	1.85		Shallow Concentrated Flow, Shallow Concentrated
					Short Grass Pasture Kv= 7.0 fps
3.8	139	Total

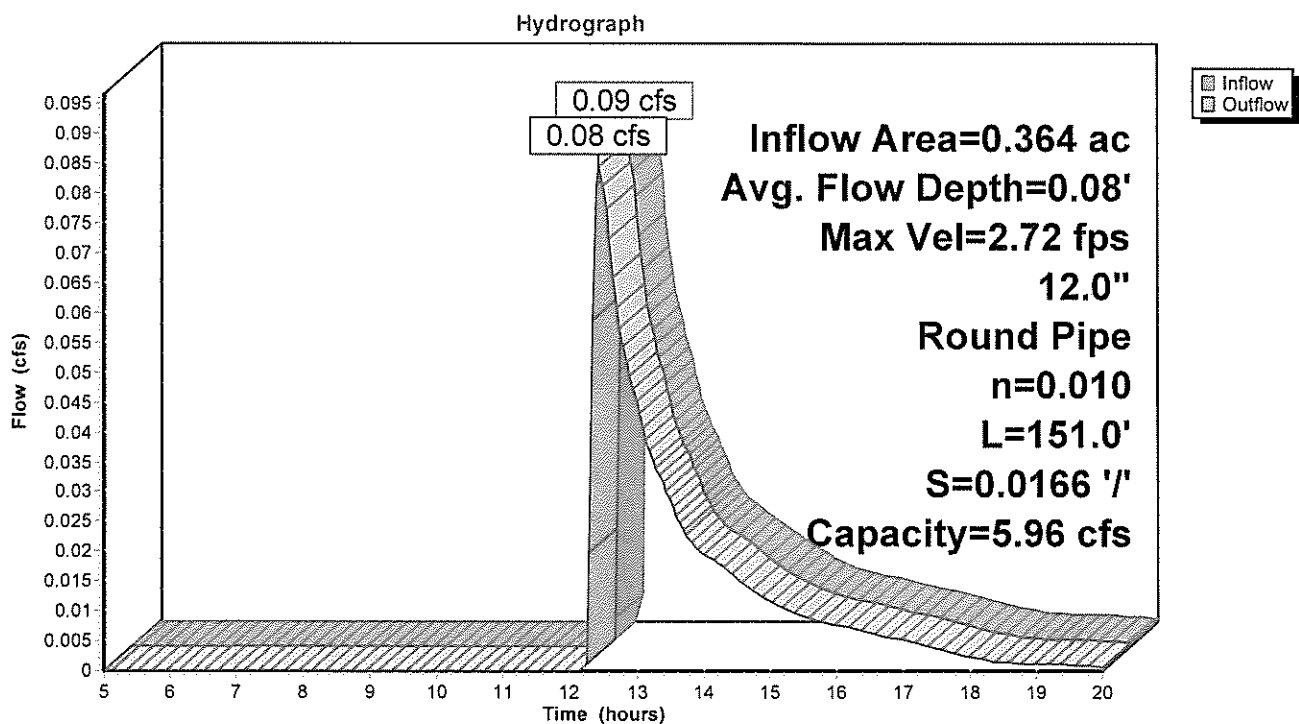
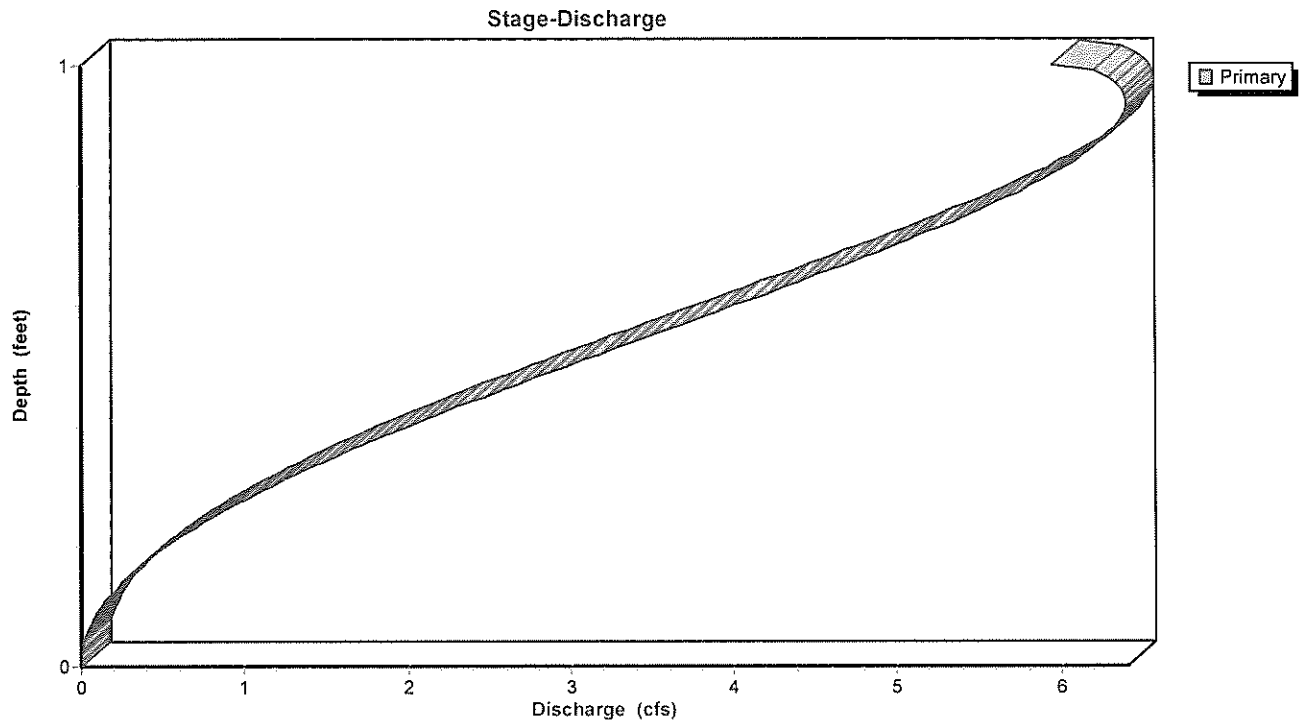
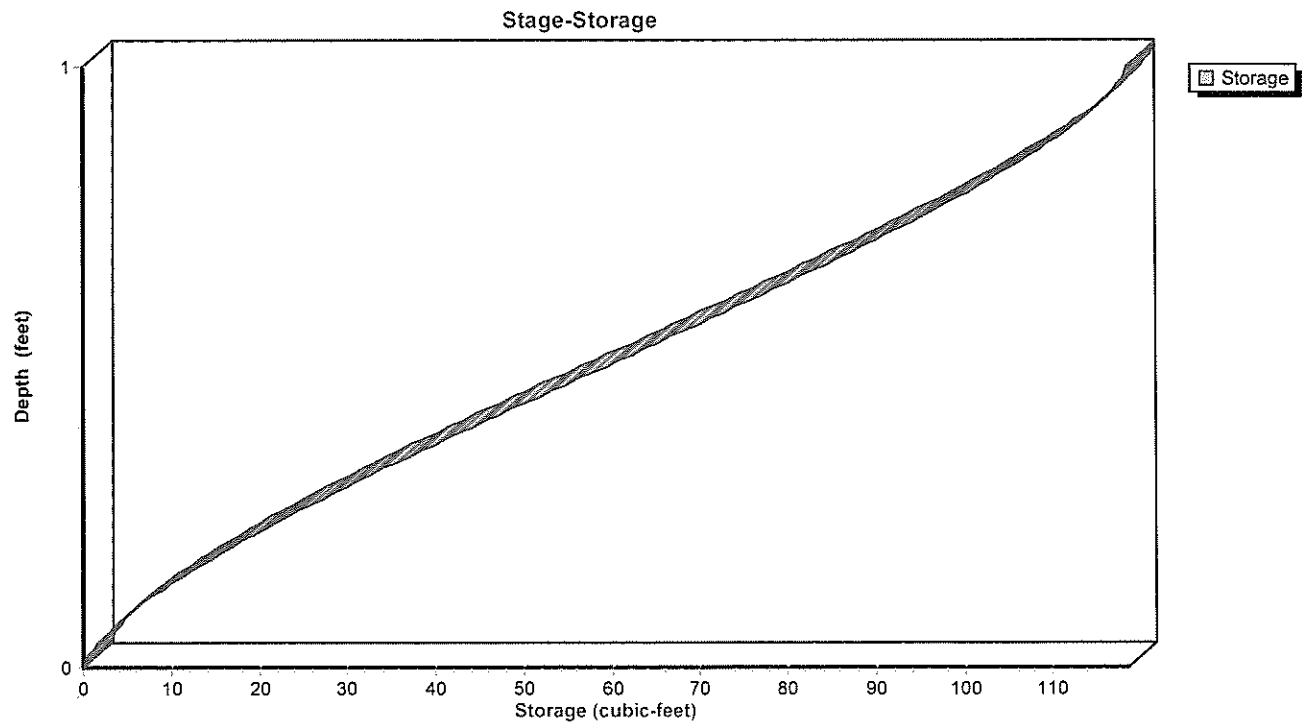
Summary for Reach DL: 12" D PVC Drail Line to CB2 in Millbury Street & Municipal Sewer

Inflow Area = 0.364 ac, 0.00% Impervious, Inflow Depth > 0.30" for 2-Year event
 Inflow = 0.09 cfs @ 12.41 hrs, Volume= 0.009 af
 Outflow = 0.08 cfs @ 12.45 hrs, Volume= 0.009 af, Atten= 2%, Lag= 2.3 min
 Routed to Link CB3 : Design Point - Municipal Catch Basin in Millbury Street

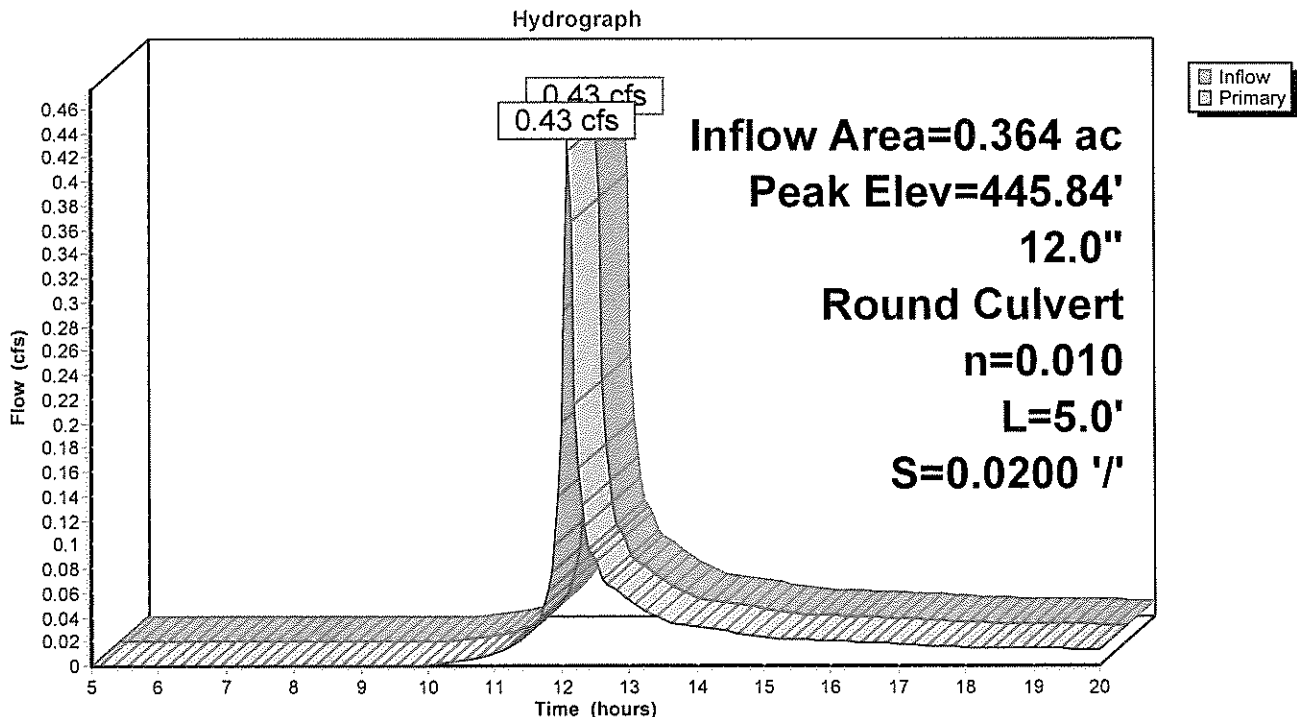
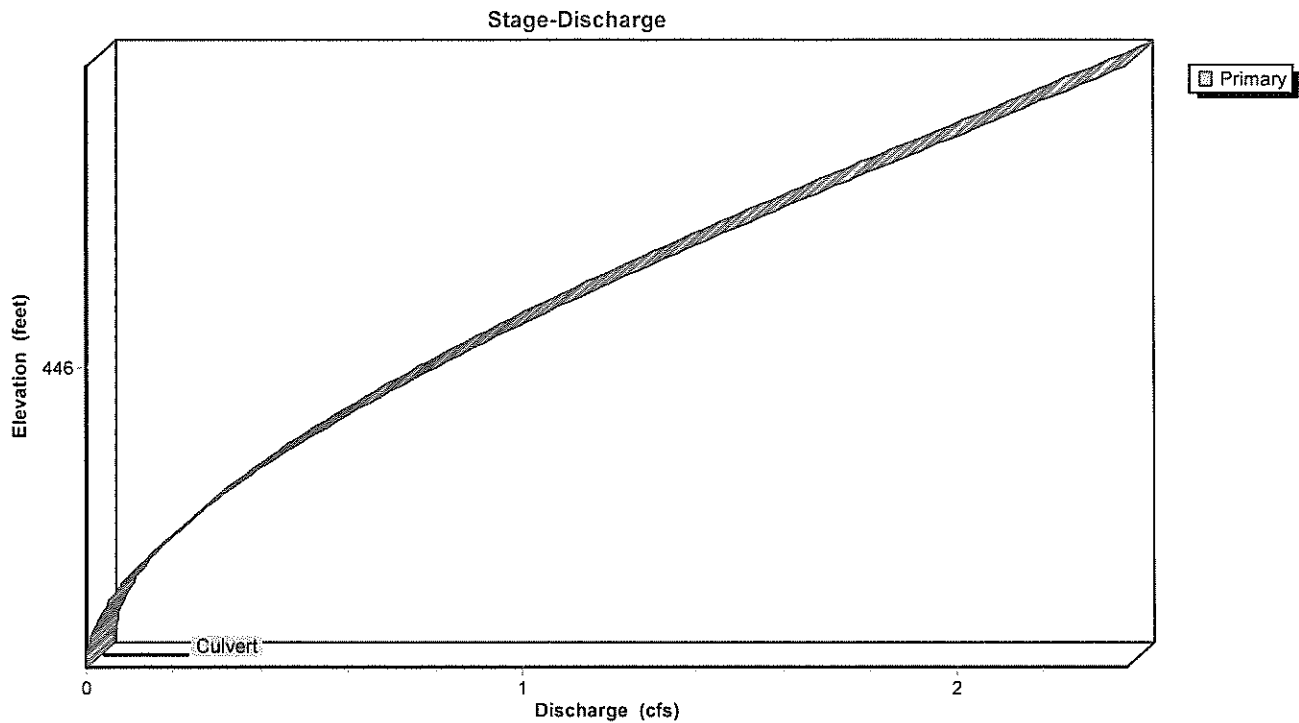
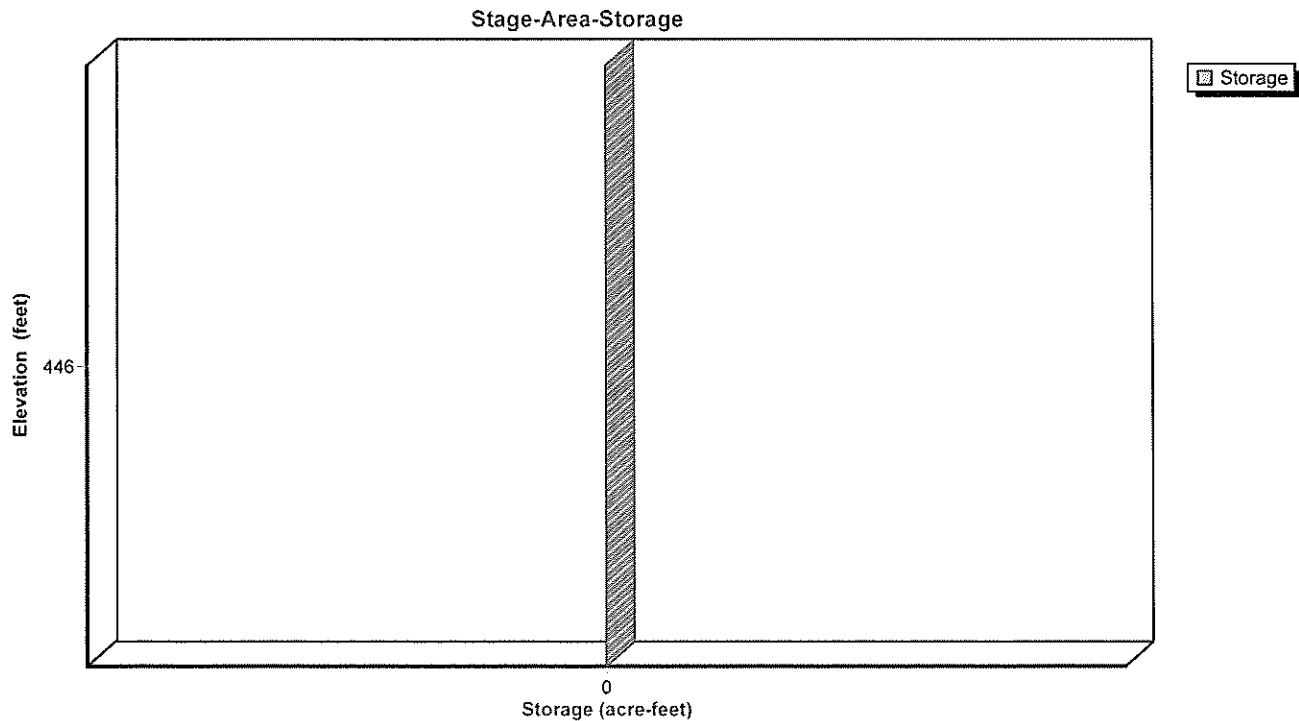
Summary for Pond CB1: Catch Basin 1

Inflow Area = 0.364 ac, 0.00% Impervious, Inflow Depth > 0.91" for 2-Year event
 Inflow = 0.43 cfs @ 12.11 hrs, Volume= 0.028 af
 Outflow = 0.43 cfs @ 12.11 hrs, Volume= 0.028 af, Atten= 0%, Lag= 0.0 min
 Primary = 0.43 cfs @ 12.11 hrs, Volume= 0.028 af
 Routed to Pond IT : Interceptor?Recharge Trench

Primary OutFlow Max=0.41 cfs @ 12.11 hrs HW=445.84' (Free Discharge)
 1=Culvert (Barrel Controls 0.41 cfs @ 2.65 fps)

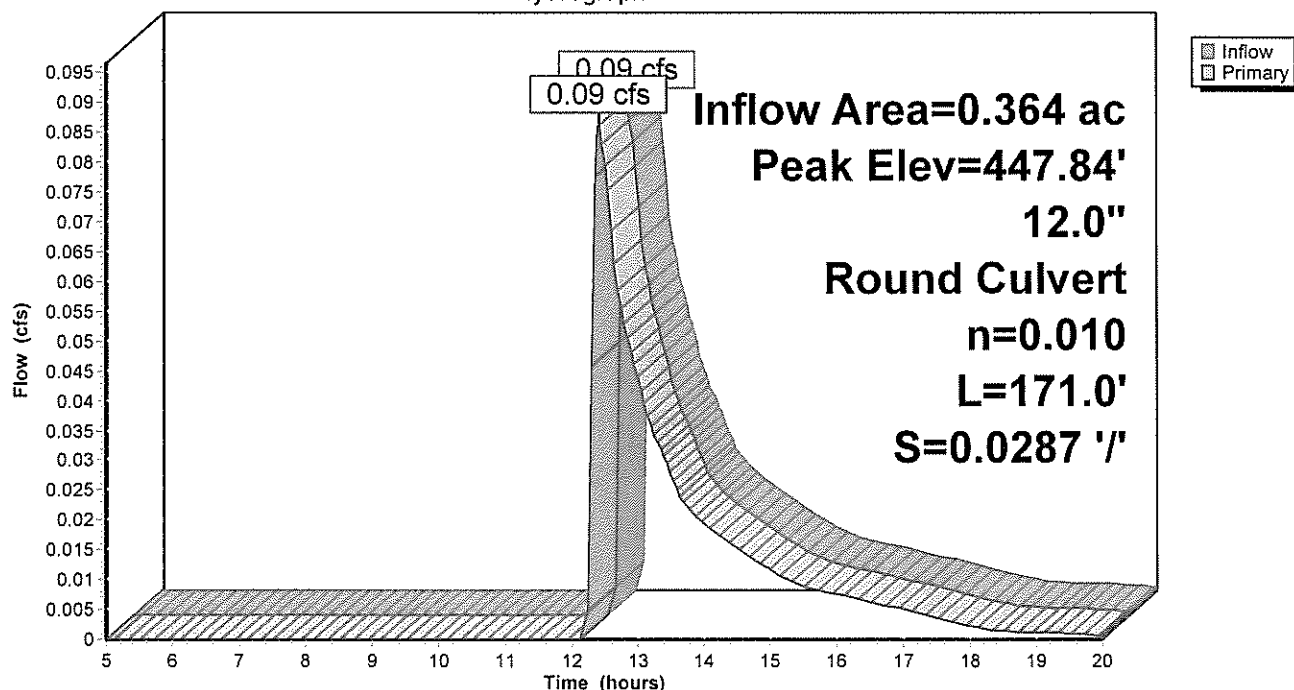
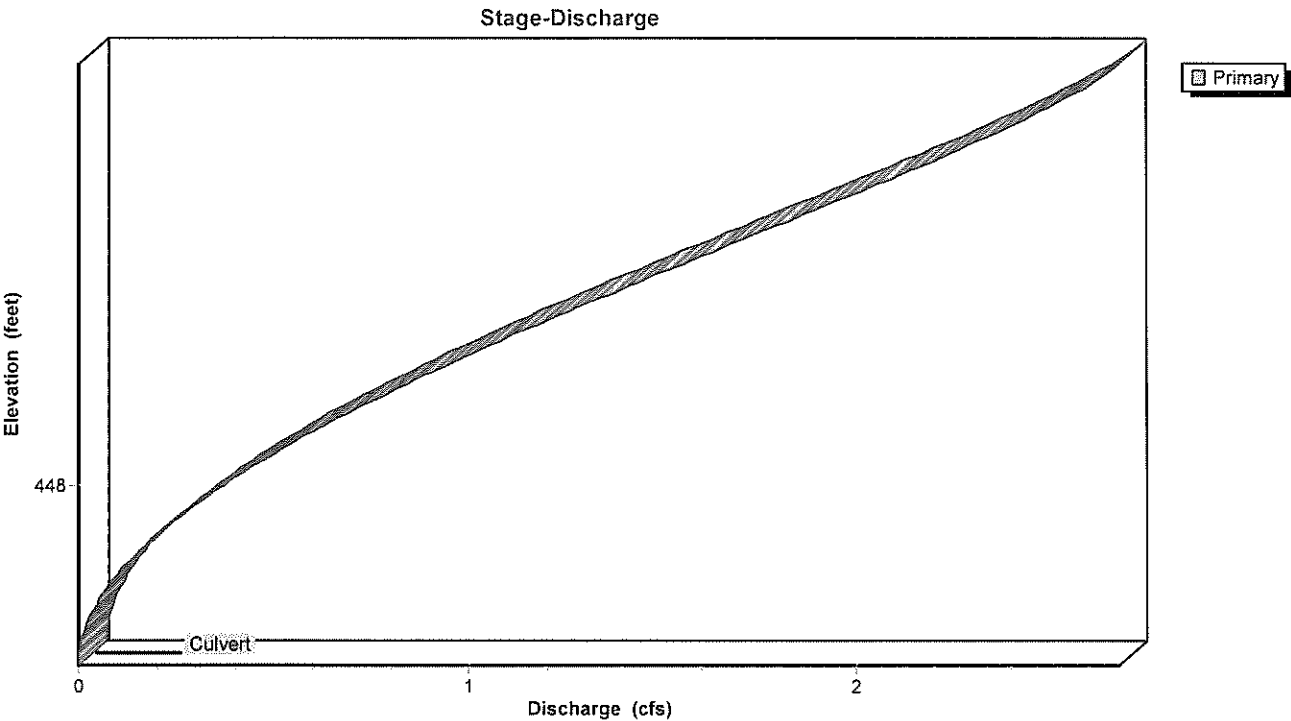
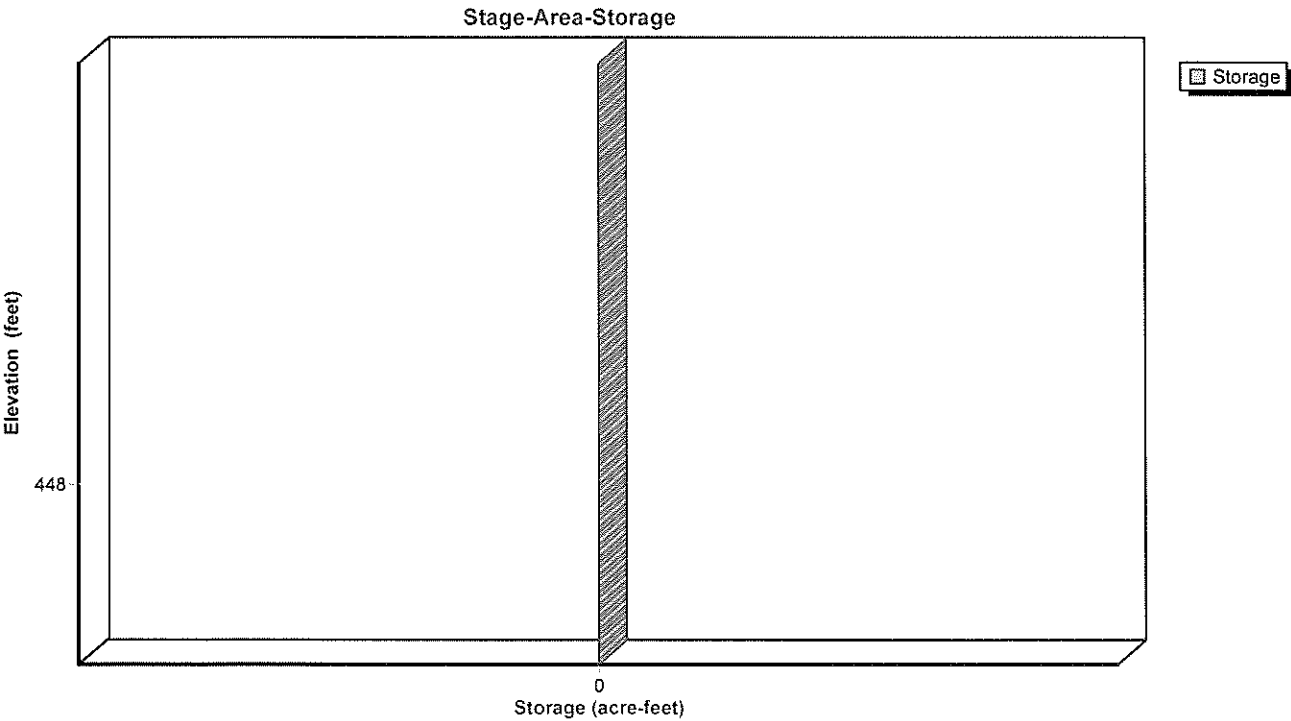
Summary for Pond CB2: Catch Basin

Inflow Area = 0.364 ac, 0.00% Impervious, Inflow Depth > 0.30" for 2-Year event
Inflow = 0.09 cfs @ 12.41 hrs, Volume= 0.009 af
Outflow = 0.09 cfs @ 12.41 hrs, Volume= 0.009 af, Atten= 0%, Lag= 0.0 min
Primary = 0.09 cfs @ 12.41 hrs, Volume= 0.009 af
Routed to Reach DL : 12" D PVC Drail Line to CB2 in Millbury Street & Municipal Sewer

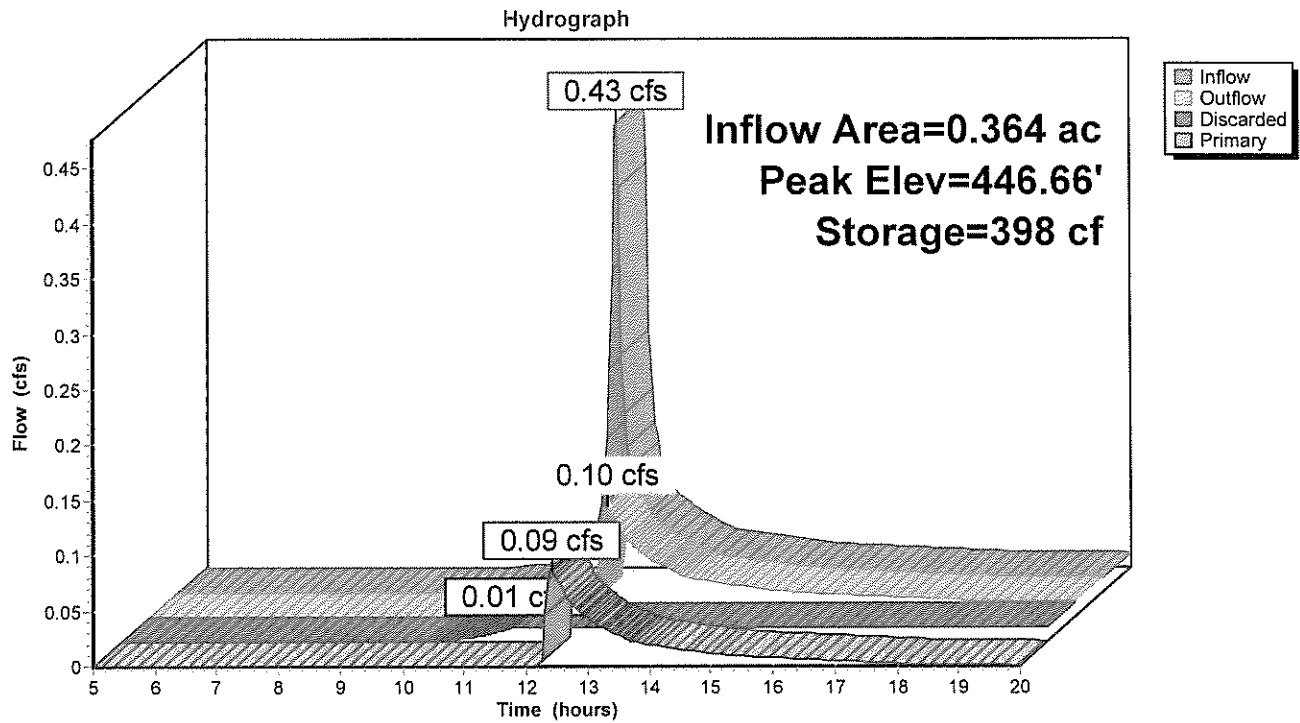
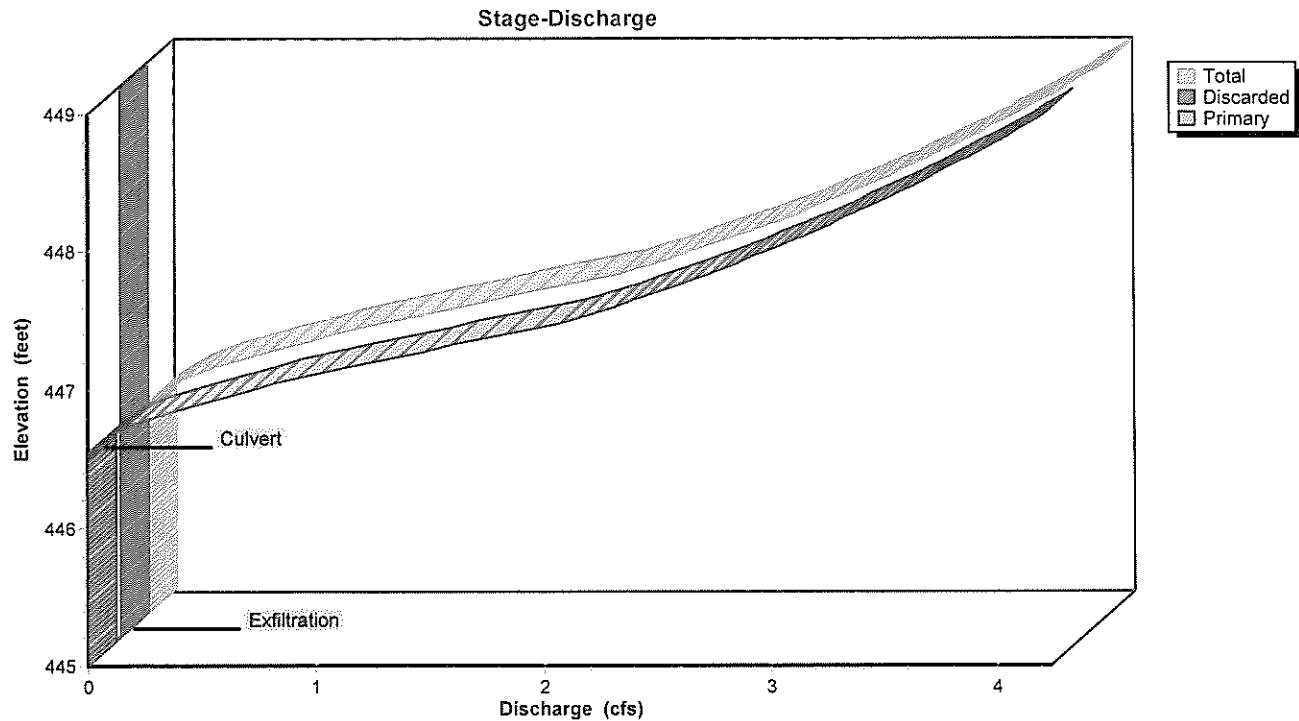
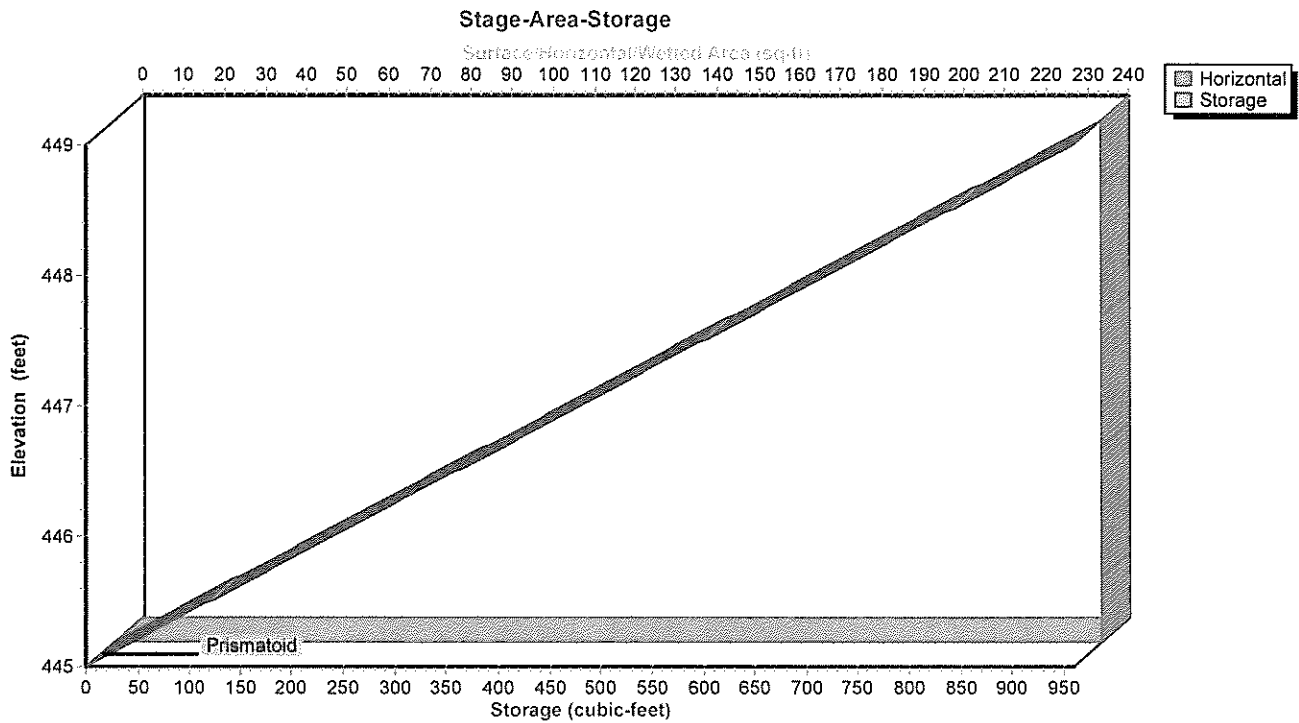
Summary for Pond IT: Interceptor?Recharge Trench

Inflow Area = 0.364 ac, 0.00% Impervious, Inflow Depth > 0.91" for 2-Year event
 Inflow = 0.43 cfs @ 12.11 hrs, Volume= 0.028 af
 Outflow = 0.10 cfs @ 12.41 hrs, Volume= 0.019 af, Atten= 77%, Lag= 18.1 min
 Discarded = 0.01 cfs @ 11.35 hrs, Volume= 0.010 af
 Primary = 0.09 cfs @ 12.41 hrs, Volume= 0.009 af
 Routed to Pond CB2 : Catch Basin

Primary OutFlow Max=0.08 cfs @ 12.41 hrs HW=446.66' (Free Discharge)
 ↑2=Culvert (Inlet Controls 0.08 cfs @ 1.07 fps)

6. Recharging Pipe System. This system is an interceptor trench and swale for the collection and infiltration of runoff. The collection system will consist of two catch basins (CB1 south & CB2 north) and a 4-foot deep by 3-foot wide stone-filled trench having a 1.5-foot deep swale top. A length of 4-inch diameter perforated PVC pipe will extend along the bottom of the trench from CB1 to CB2. A drain line extending from the CB2 down to a catch basin (CB3) in Millbury Street will convey excess water to the municipal sewerage.

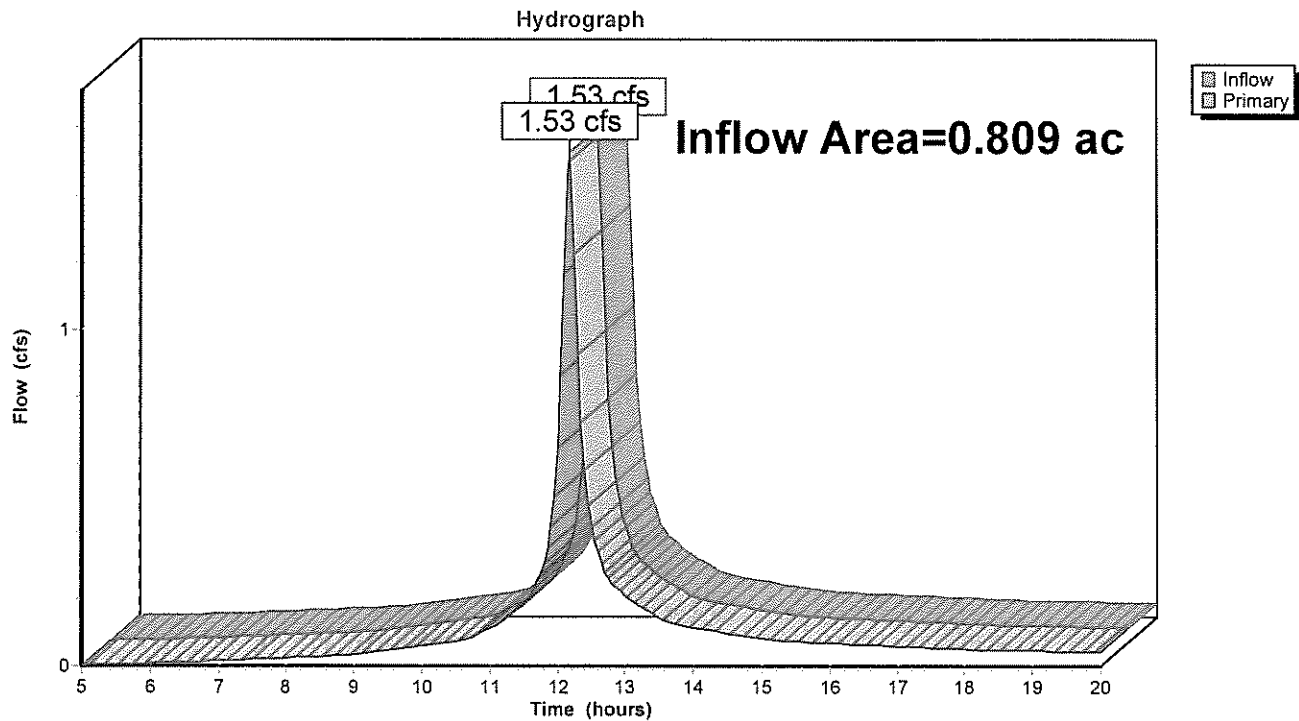
Summary for Link C-M.S.: Design Point - Current Conditions - Millbury Street

Inflow Area = 0.809 ac, 11.27% Impervious, Inflow Depth > 1.91" for 2-Year event
Inflow = 1.53 cfs @ 12.18 hrs, Volume= 0.129 af
Primary = 1.53 cfs @ 12.18 hrs, Volume= 0.129 af, Atten= 0%, Lag= 0.0 min

Primary outflow = Inflow, Time Span= 5.00-20.00 hrs, dt= 0.05 hrs

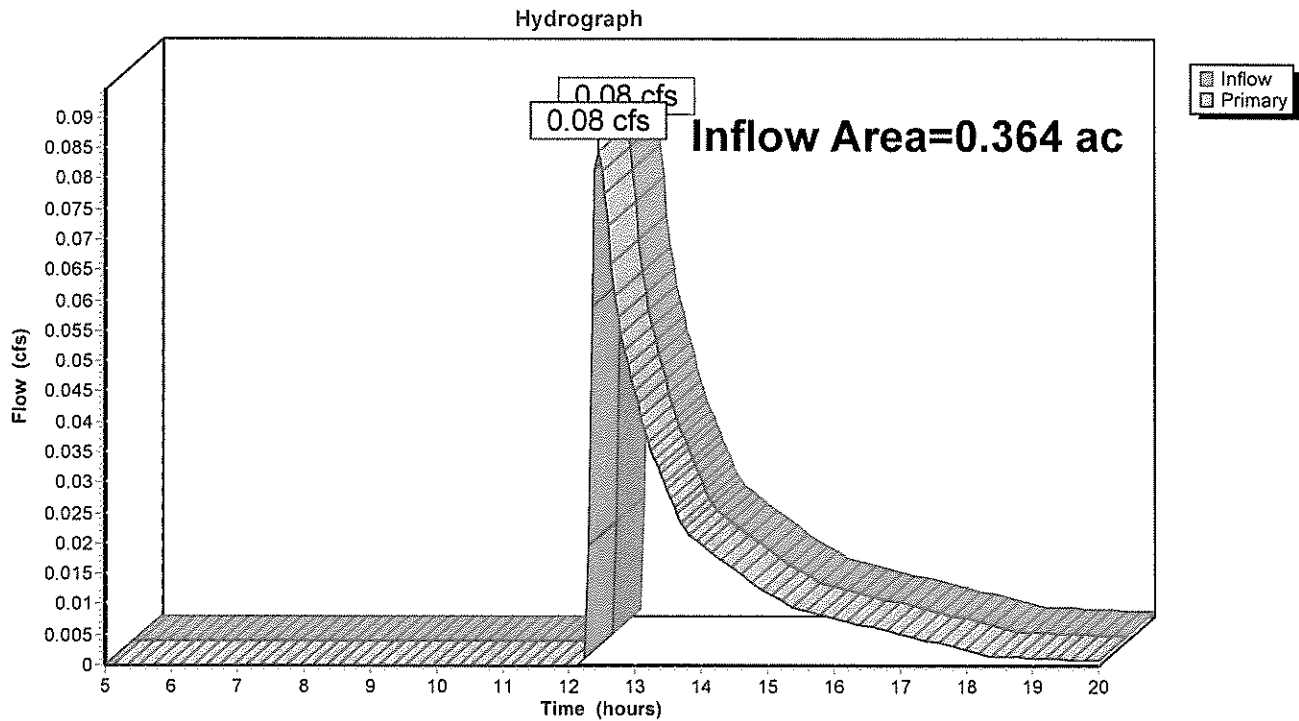
Summary for Link CB3: Design Point - Municipal Catch Basin in Millbury Street

Inflow Area = 0.364 ac, 0.00% Impervious, Inflow Depth > 0.30" for 2-Year event
 Inflow = 0.08 cfs @ 12.45 hrs, Volume= 0.009 af
 Primary = 0.08 cfs @ 12.45 hrs, Volume= 0.009 af, Atten= 0%, Lag= 0.0 min

Primary outflow = Inflow, Time Span= 5.00-20.00 hrs, dt= 0.05 hrs

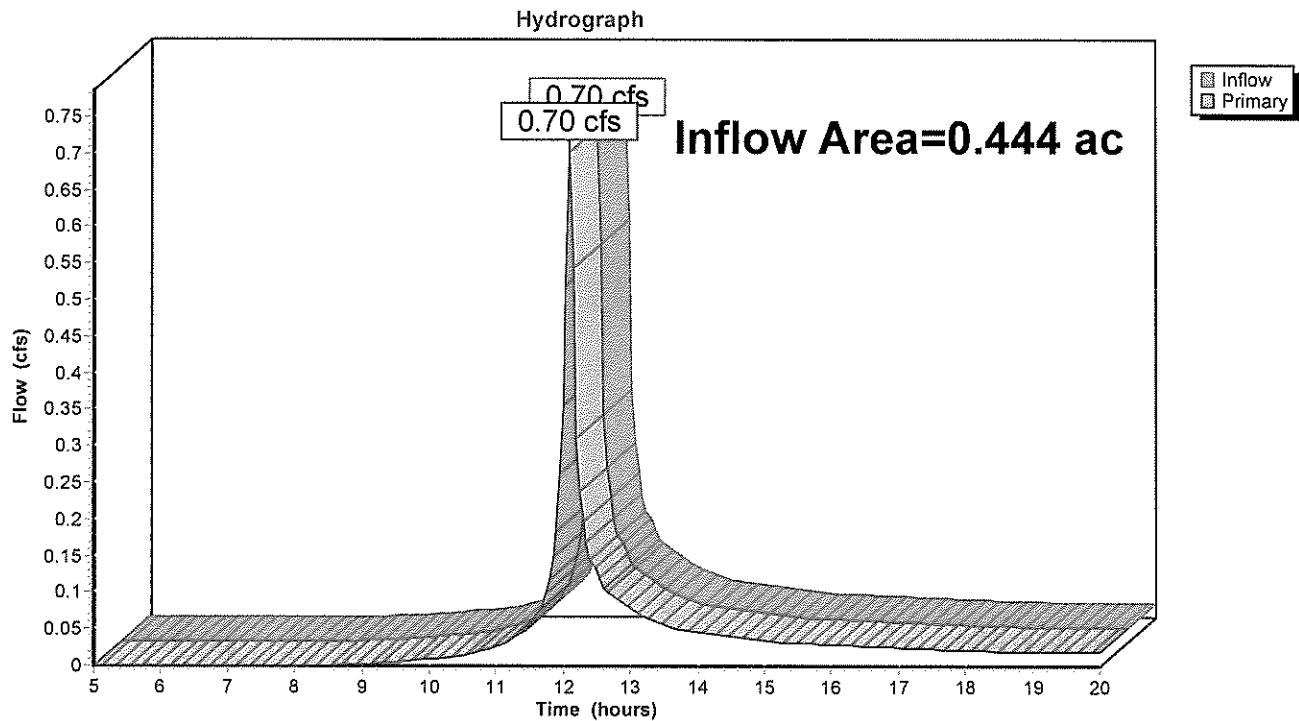
Summary for Link MS: Design Point - Millbury Street

Inflow Area = 0.444 ac, 20.50% Impervious, Inflow Depth > 1.20" for 2-Year event
 Inflow = 0.70 cfs @ 12.10 hrs, Volume= 0.044 af
 Primary = 0.70 cfs @ 12.10 hrs, Volume= 0.044 af, Atten= 0%, Lag= 0.0 min

Primary outflow = Inflow, Time Span= 5.00-20.00 hrs, dt= 0.05 hrs

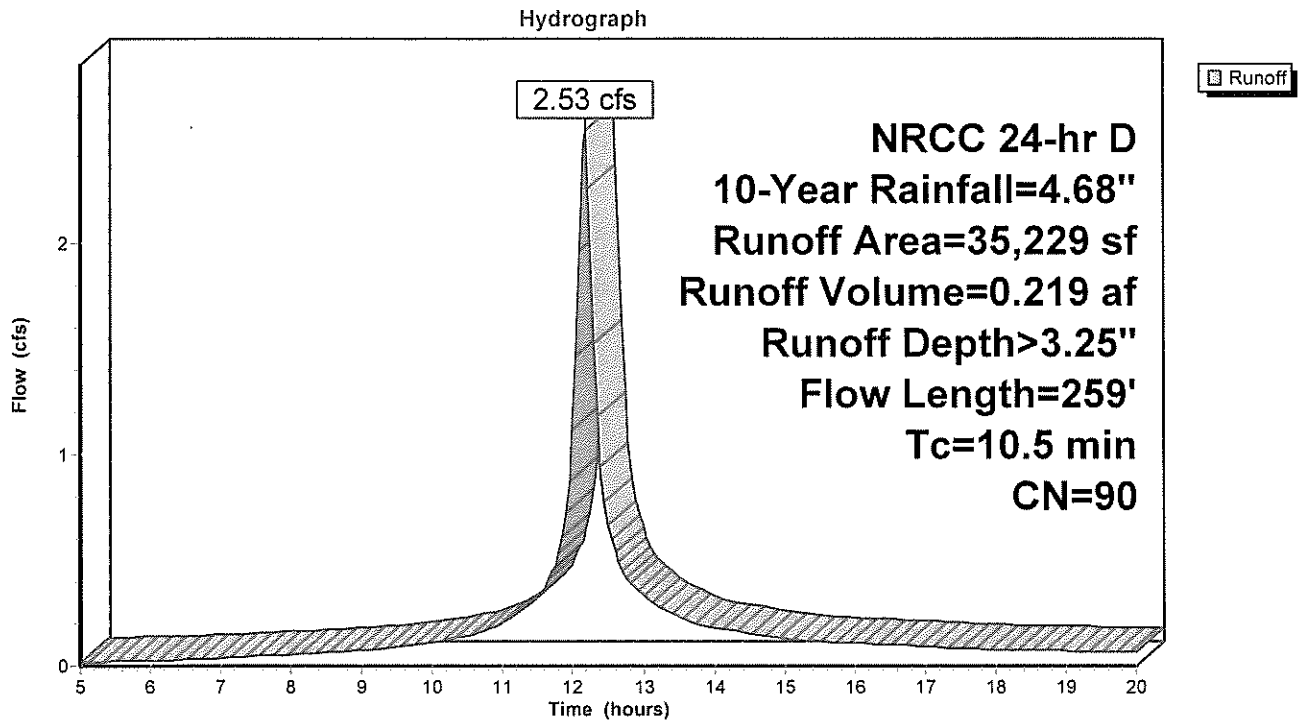
Subcatchment 1089: Current 2020 Conditions 1087-1089 Millbury St. TOTAL LOT

Tc (min)	Length (feet)	Slope (ft/ft)	Velocity (ft/sec)	Capacity (cfs)	Description
9.8	32	0.0600	0.05		Sheet Flow, Sheet Flow Woods: Dense underbrush n= 0.800 P2= 3.13"
0.1	73	0.4500	10.80		Shallow Concentrated Flow, Shallow Concentrated Unpaved Kv= 16.1 fps
0.6	154	0.0840	4.67		Shallow Concentrated Flow, Shallow Concentrated Unpaved Kv= 16.1 fps
10.5	259	Total

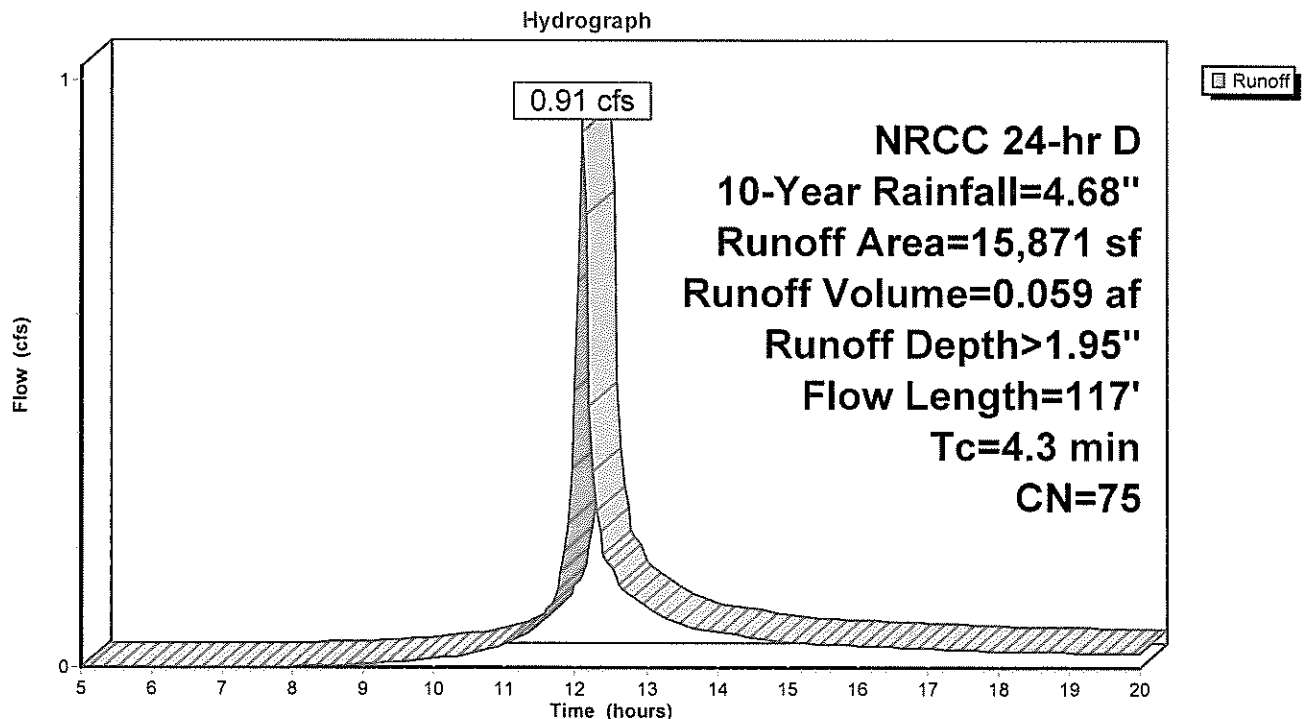
Subcatchment P-A: Poposed 2021 Conditions 1087-1089 Millbury St. Upper Section to Drain Syst

ary for Subcatchment P-A: Poposed 2021 Conditions 1087-1089 Millbury St. Upper Section to Dra

Runoff = 0.91 cfs @ 12.11 hrs, Volume= 0.059 af, Depth> 1.95"
 Routed to Pond CB1 : Catch Basin 1

Tc (min)	Length (feet)	Slope (ft/ft)	Velocity (ft/sec)	Capacity (cfs)	Description
2.4	10	0.2000	0.07		Sheet Flow, Sheet Flow-1 Trees
					Woods: Dense underbrush n= 0.800 P2= 3.13"
1.6	40	0.3000	0.41		Sheet Flow, Sheet Flow 2 - Grass
					Grass: Short n= 0.150 P2= 3.13"
0.3	67	0.3000	3.83		Shallow Concentrated Flow, Shallow Concentrated
					Short Grass Pasture Kv= 7.0 fps
4.3	117	Total

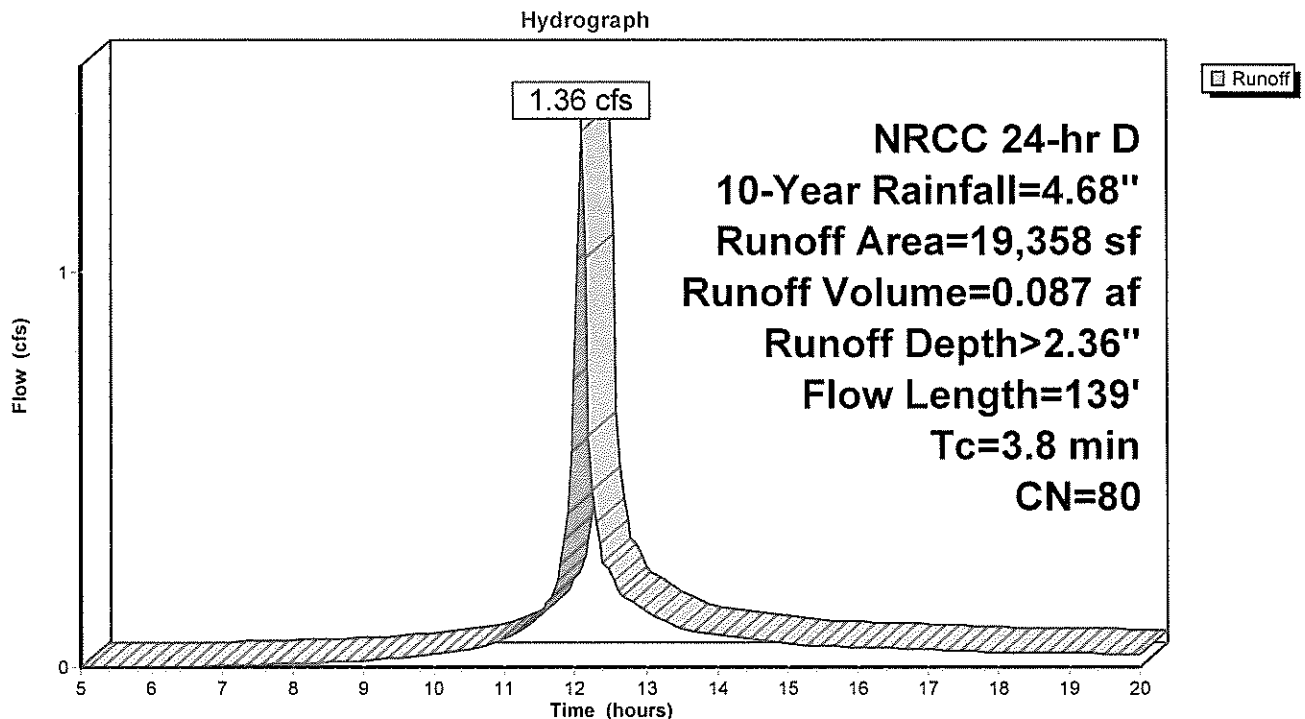
Subcatchment P-B: Poposed 2021 Conditions 1087-1089 Millbury St. Lower Section To Millbury St

ry for Subcatchment P-B: Poposed 2021 Conditions 1087-1089 Millbury St. Lower Section To Mill

Runoff = 1.36 cfs @ 12.10 hrs, Volume= 0.087 af, Depth> 2.36"
 Routed to Link MS : Design Point - Millbury Street

Tc (min)	Length (feet)	Slope (ft/ft)	Velocity (ft/sec)	Capacity (cfs)	Description
3.0	50	0.1000	0.28		Sheet Flow, Sheet Flow - Grass
					Grass: Short n= 0.150 P2= 3.13"
0.8	89	0.0700	1.85		Shallow Concentrated Flow, Shallow Concentrated
					Short Grass Pasture Kv= 7.0 fps
3.8	139	Total
